## ENVIRONMENTAL WASTE SITE CHARACTERIZATION UTILIZING AERIAL PHOTOGRAPHS AND SATELLITE IMAGERY: THREE SITES IN NEW MEXICO, USA

**Ed Van Eeckhout, Paul Pope, Cheryl Rofer, Naomi Becker, and Bob Wells**

Los Alamos National Laboratory, MS C335, Los Alamos NM 87545 USA

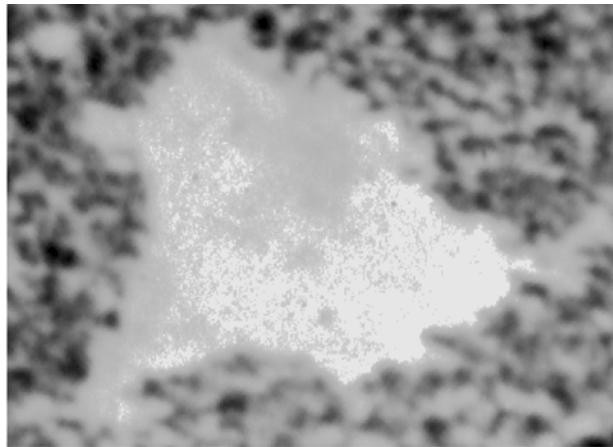
Fig. 10(a). 1935 image of MDA-M area.

The registered images shown in Figs. 10(a)-(f) were visually interpreted by viewing an on-screen animation of these images. This analysis allowed the following physical history of MDA-M to be derived. The 1935 image illustrated the fact that this area was an open space even before Los Alamos was established (Fig. 10(a)). Stereoscopic viewing of the 1935 stereo pair revealed many trails around this area which were most likely created by homesteaders who were in the region at the time.

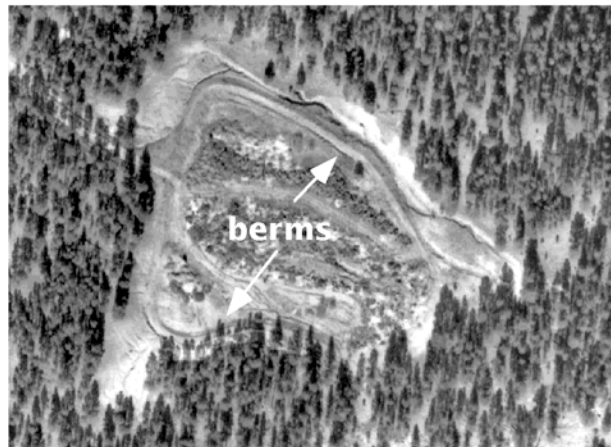
Fig. 10(d). 1958 image of MDA-M area.

Drainage patterns across the area are clearly visible in the 1947 image, possibly due to heavy vegetation cover within the drainage, increased moisture, and/or high contrast due to shadowing effects. The changes in drainage across the area due to creation of the berm are clearly visible in the 1958 image.

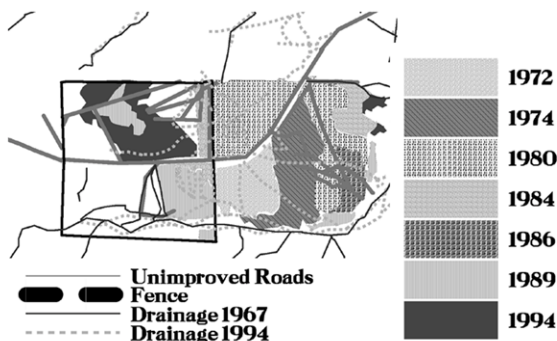
Fig. 12. Vector map created from animation of multitemporal imagery

These multirate images were transformed so that they matched a base image in scale, orientation, and extent. An Affine transformation and nearest neighbor resampling were used. The 1994 photo served as the base image. The coregistered images were animated on-screen to study the changes in the site over time. The largest changes were associated with the growth of the landfill. The extent of the landfill was digitized from each image. These boundaries were used to create a vector map of the annual growth of the site from 1955 through June of 1994. This map is shown in Fig. 12.

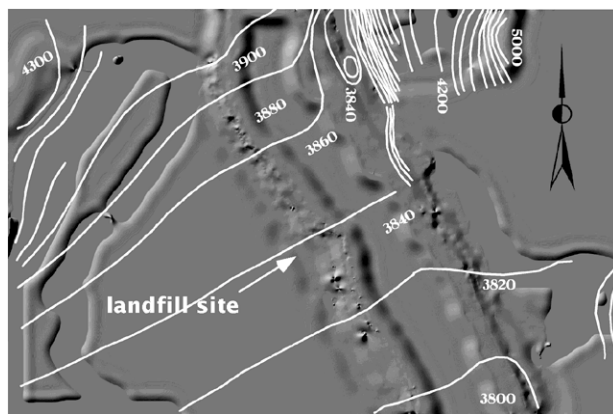
Fig. 13. Water gradient contours overlaid on 3-D water surface.

The Mesilla Valley water table is 10-25 feet below land surface and has a south dipping gradient at approximately 4.5 feet per mile (Wilson et al., 1981). This gradient forces the direction of water flow to the south. See Fig. 13 for water gradient contours. In general, the ground-water in this region occurs under confined conditions, because clay has reduced the vertical permeability.
